GT Refresh

Overview of Product Changes

GMI Sales Awareness 8th October 2020

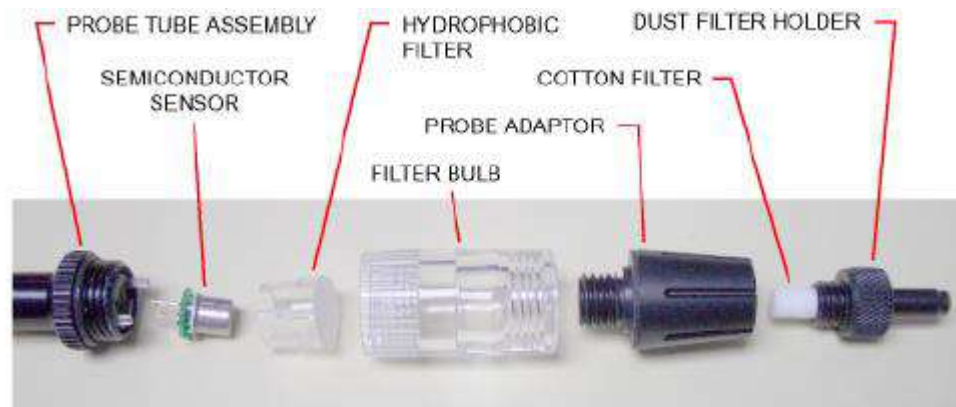
Old design

Problem:

Pumps failing in the field. Pump line blocked with dust and debris.

Root Cause:

Bulb filtering did not provide a satisfactory seal. It allowed dust/debris particles to bypass the filter. This resulted pump performance degradation or failure.

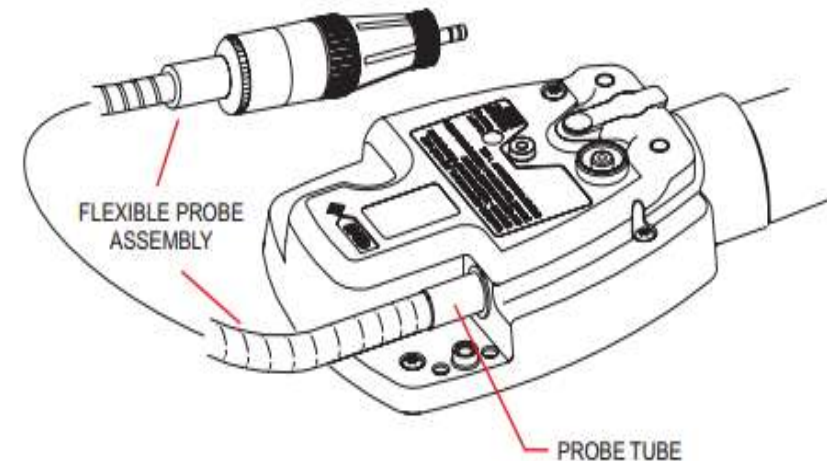
Problem:

Loose probes, broken probe wires.

Root Cause:

Probe held by a grub screw. Grub screw is not sufficient to hold the probe with repeated movement. Causes the probe to come loose and can cause the internal wires to break.

Correction:

As part of maintenance regime probe glued in position on existing instruments

Corrective action: CN6363/6381

Probe glued in position on new builds.

A new spare rear assembly made with probe glued in position.

Implemented March 2014

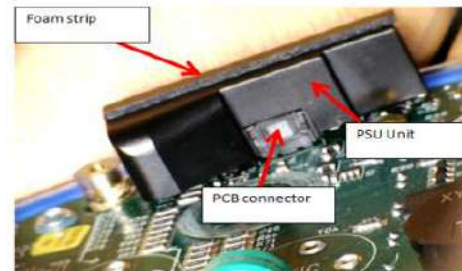
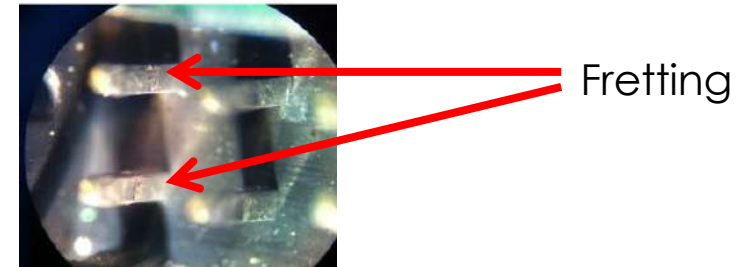
Problem:

Various power failures would appear or disappear depending how tightly the housings were pressed or screwed together.

Root Cause:

Signs of fretting between mating connectors of PSU.

Pump causing movements/vibrations resulting in fretting on tin plated contacts

Correction:

PSU contact cleaning process implemented

Corrective action: CN6366

Gold connectors less prone to fretting. PSU connectors updated to gold plated parts. Implemented foam strip to immobilise the PSU.

Implemented Sep 2014

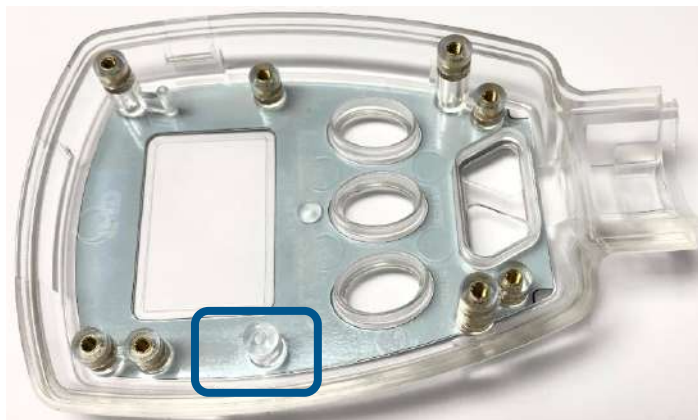
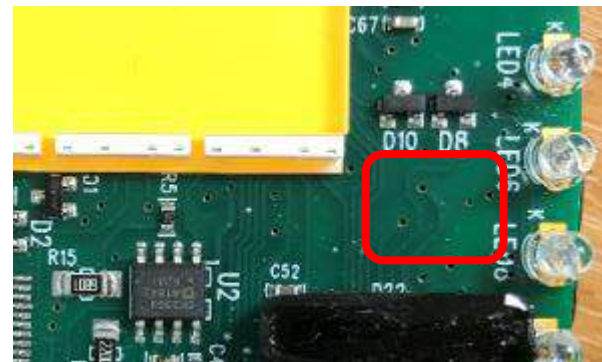
Problem:

Bead Fault/Wrench on LEL range. The failure would appear or disappear depending how strongly the housings were pressed or screwed together.

Root Cause:

Brass insert in position but is not needed. Brass insert was flush and could result in a short circuit across PCB tracks when the instrument is compressed/assembled.

The tracks at risk of being shorted are "BEAD SENSE" to GND. This would imply the sensor is faulty where it is not.

Corrective action: CN6390

Removed insert at position shown on below. **Implemented May 2014**

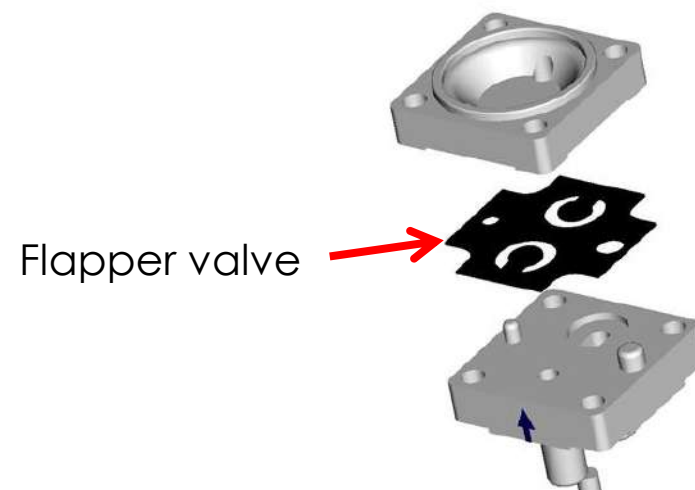
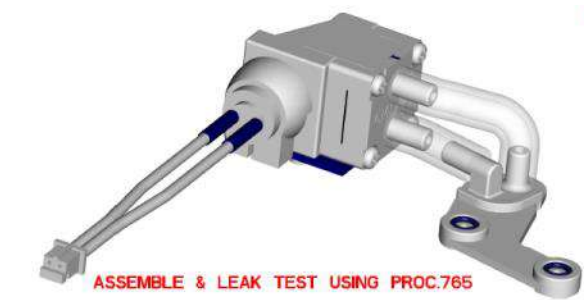
Problem:

Variation in pump performance.

Root Cause:

Rubber pump flapper valve is chlorinated. The chlorination is intended to make the rubber more robust. However, the chlorination process is not easily controlled, results in variation in the rubber flexibility affecting the pump performance.

Corrective action:

- Pump flapper valve changed to unchlorinated material. Long term testing showed no deterioration in pump performance.
- Assembly methods reviewed.
- Production visual management tools implemented to monitor pump yield.

Implemented June 2014
